US/RAS/92/120

**Regional Programme for Pollution control in the Tanning Industry
in South-East Asia**

**SAFE LANDFILL FOR DISPOSAL OF SLUDGE FROM TANNERY
EFFLUENT TREATMENT PLANTS**

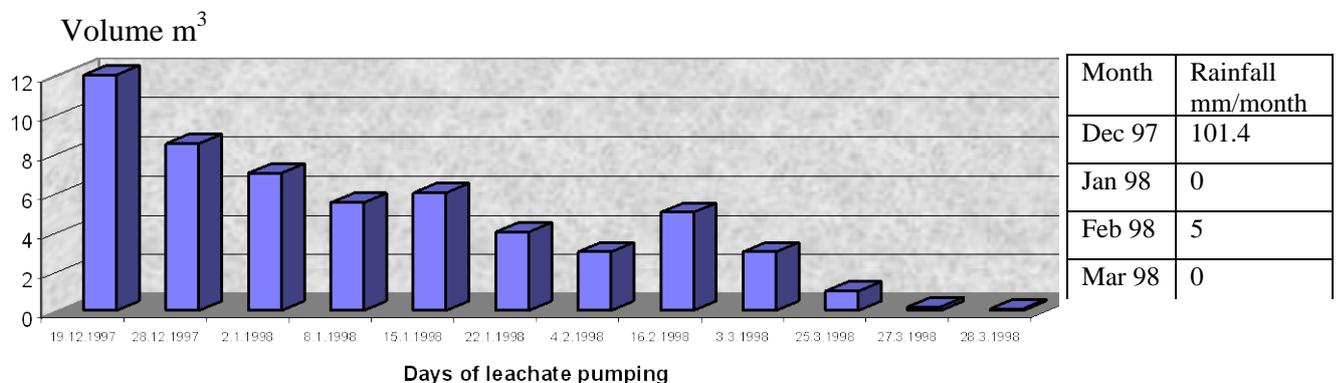
Figure 1: Reduction in leachate volume with leachate recycling

Accordingly, the leachate was sprayed back weekly from second week of December 1997 on top of the deposited sludge heap. This arrangement was found very effective, as the volume of leachate progressively reduced and finally stopped altogether. The volume of leachate pumped out (measured approximately using the pumping rate) is given in figure 1: The rainfall during the period in the area too is given for reference.

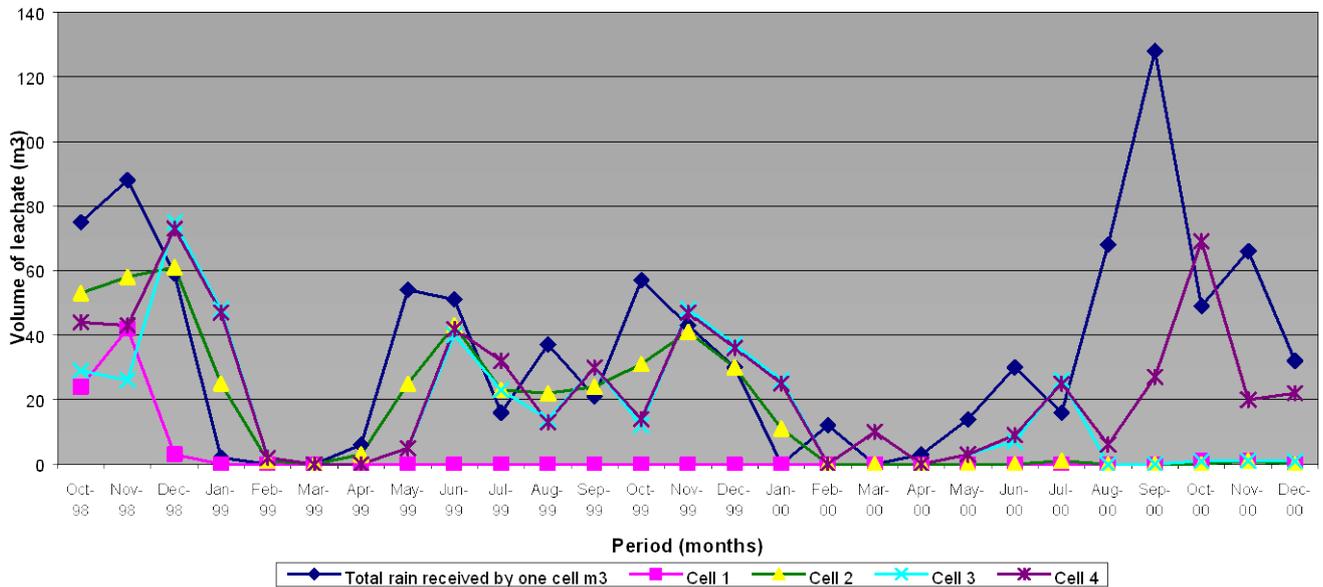
Figure 2: Rainwater versus leachate generation

No regular and monitored pumping of leachate from the cells was carried out till the beginning of October, 98. From October 98 onwards, regular pumping of leachate was started. The volume of rain water that entered the cells and the leachate pumped out from October 98 till date are given in figure 2:

Following closure of the cells, the leachate generation has become virtually negligible. This supports the hypothesis that much of the leachate generated from sludge dumped in the landfill is due to the entry of rainwater and not due to crushing of the sludge.

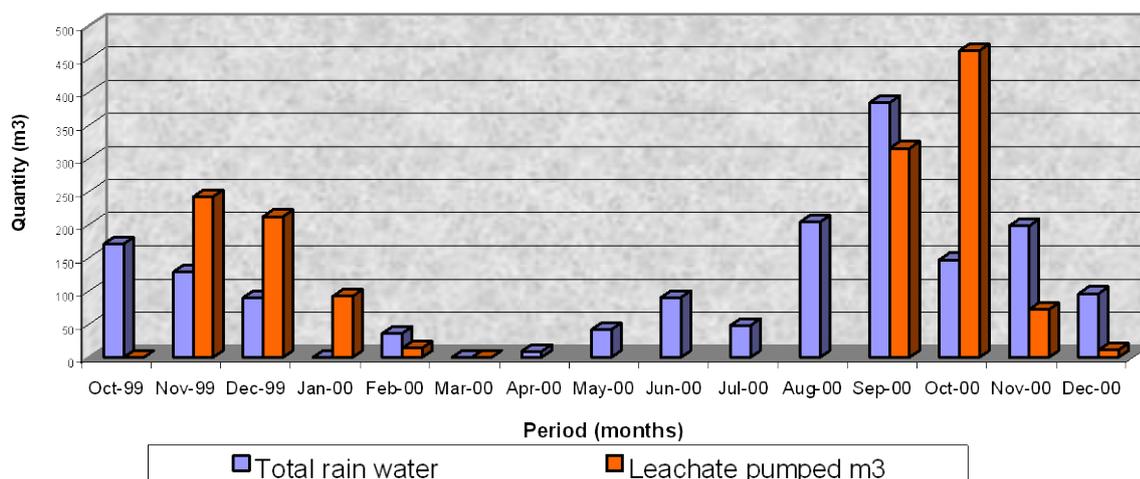
Figure 3: Water received by landfill due to rainfall and leachate generation

Until now, leachate was generated by the landfill only during two stretches and the entire leachate was pumped back to the top of the landfill for evaporation. The volume of leachate generation during the two stretches of leachate pumping along with the total volume of water received by landfill as rainfall is given in Figure 3:

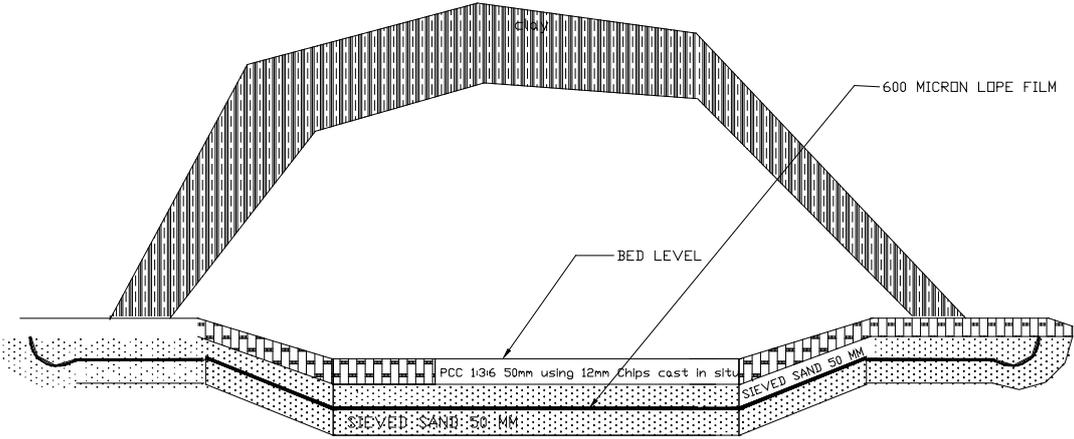
ANNEX 1
DESIGN OF TEMPORARY LANDFILL PROPOSED BY Mr. PENTTI RANTALA

The landfill, constructed in four cells, was developed generally based on the design prepared by Mr. Pentti Rantala, the schematic representation of which is given in Annex 1. The details of this landfill are discussed in subsequent sections.

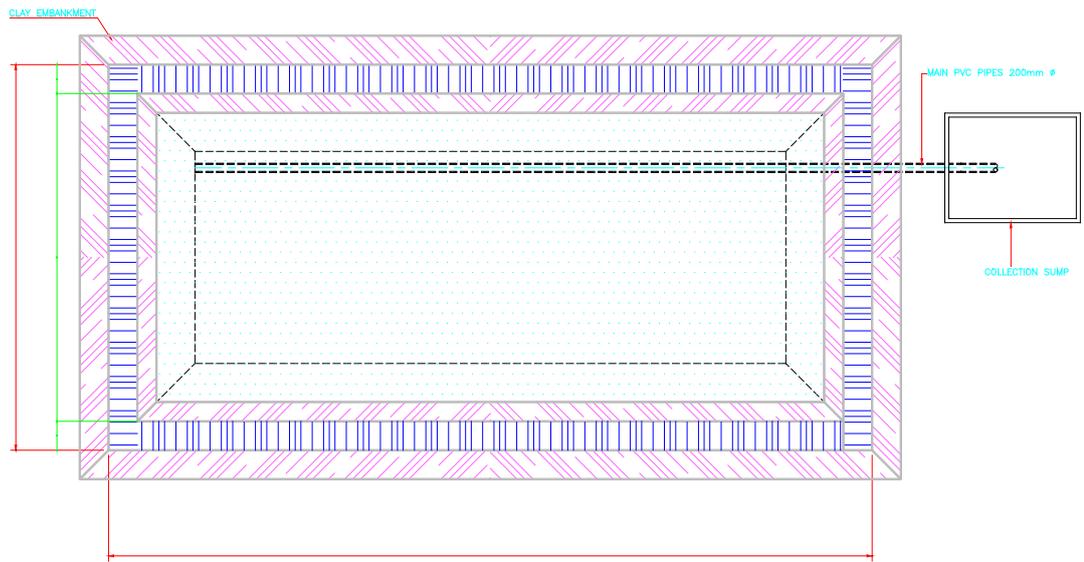
Annex 3B : VISHTEC LANDFILL – PLAN

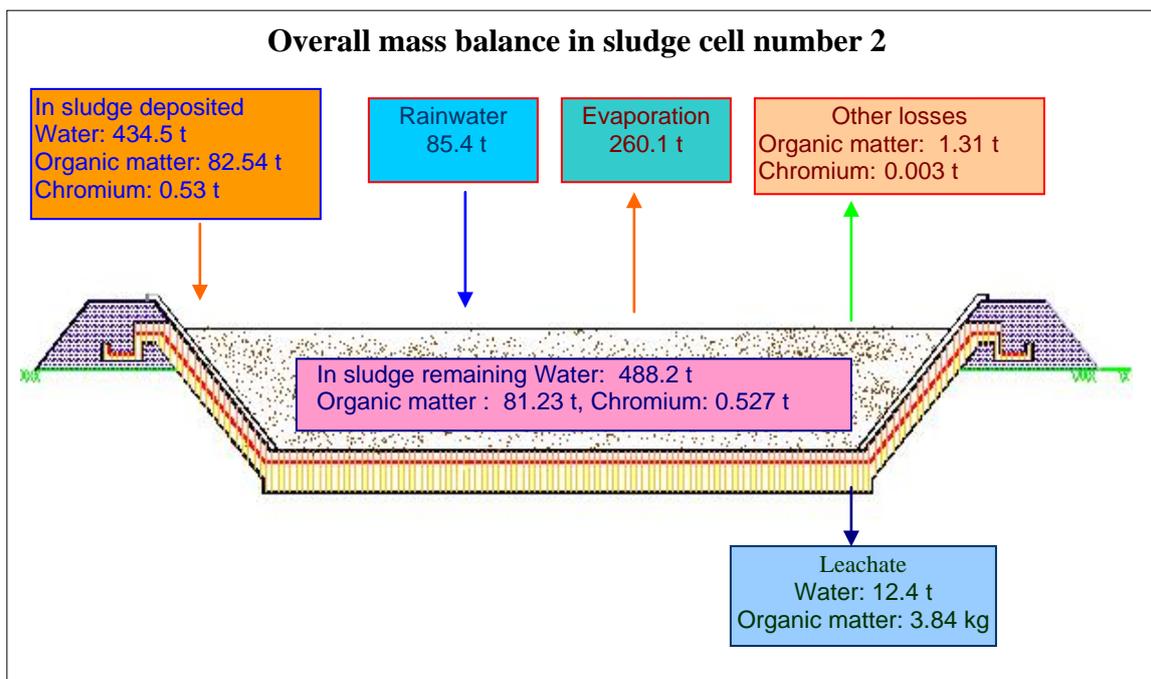
Overall mass balance of sludge landfill at Ranitec (Part –1)

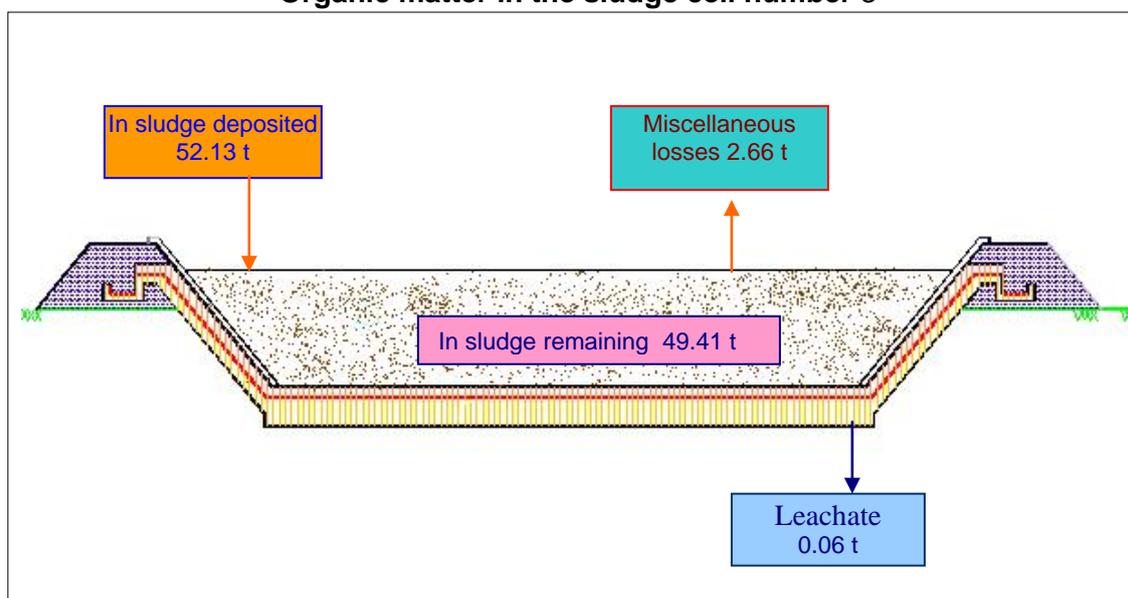
Organic matter in the sludge cell number 3

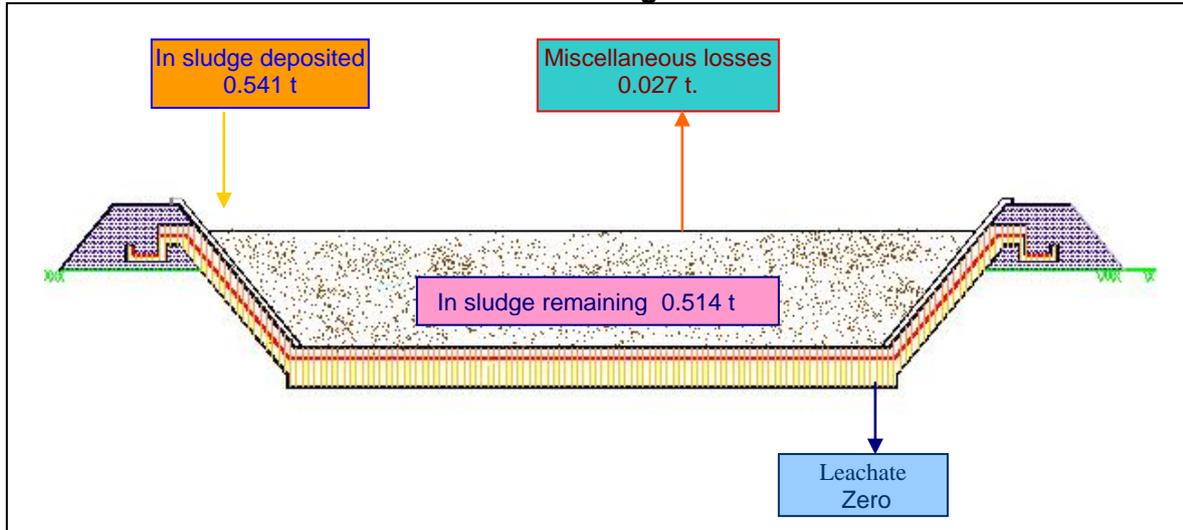
Chromium in the sludge cell number 3

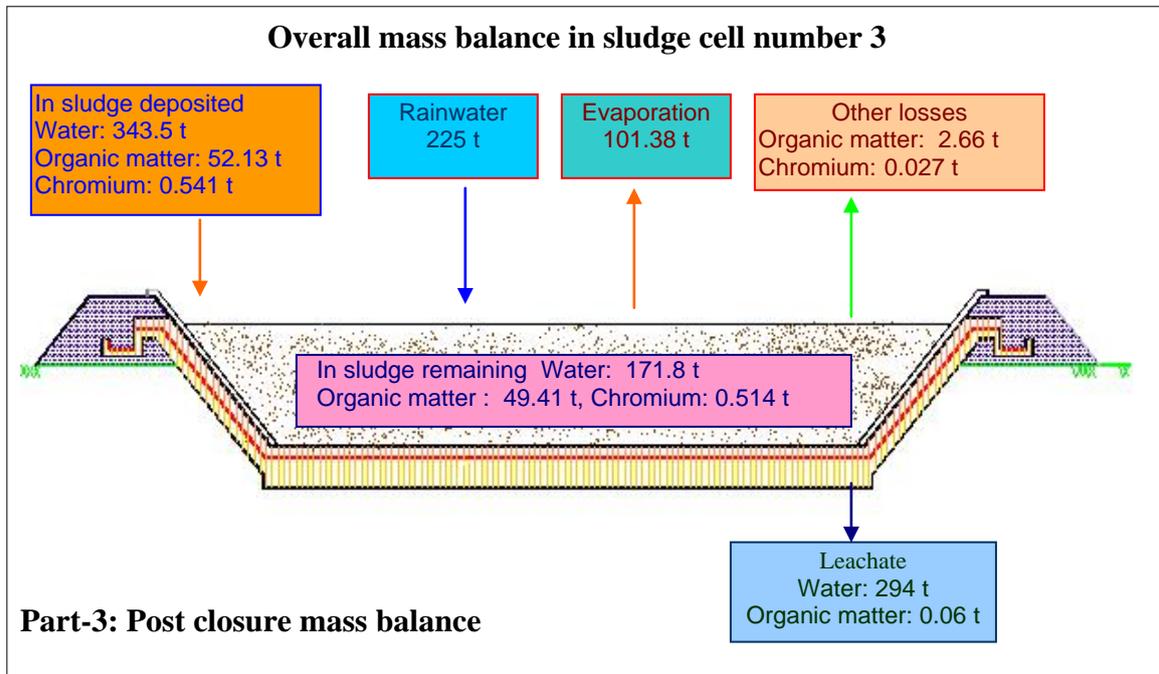
Overall mass Balance of sludge landfill at Ranitec (Part -2)

Overall mass balance in sludge cell number 3

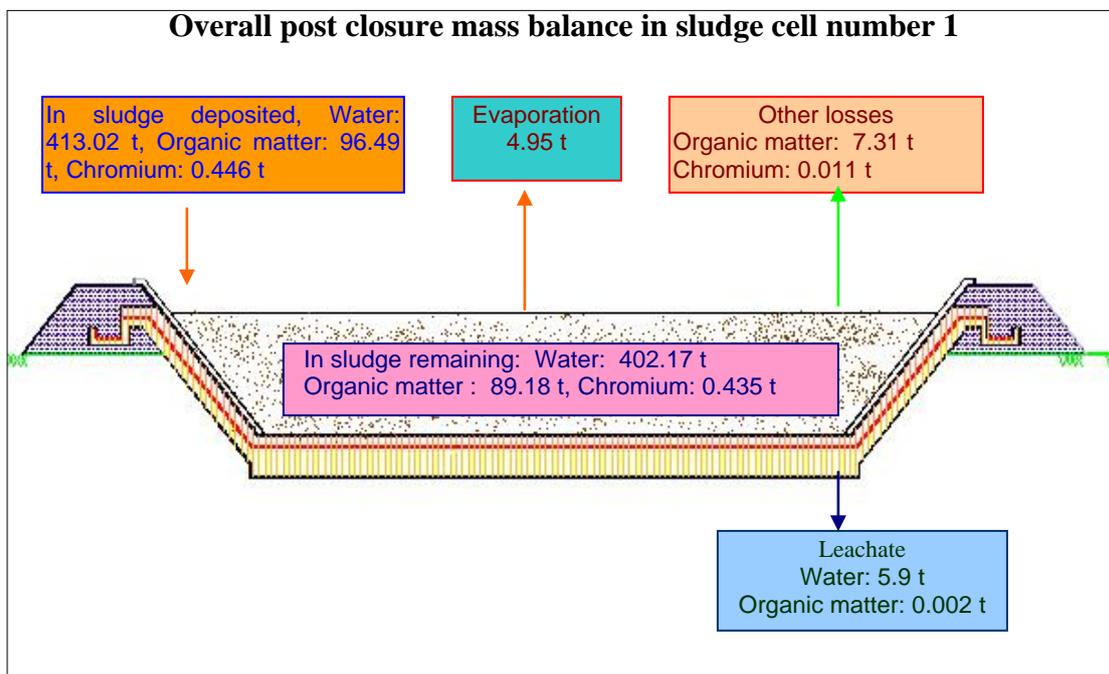
Overall Post closure mass balance of Cell-1 of sludge landfill at Ranitec (Part –3)

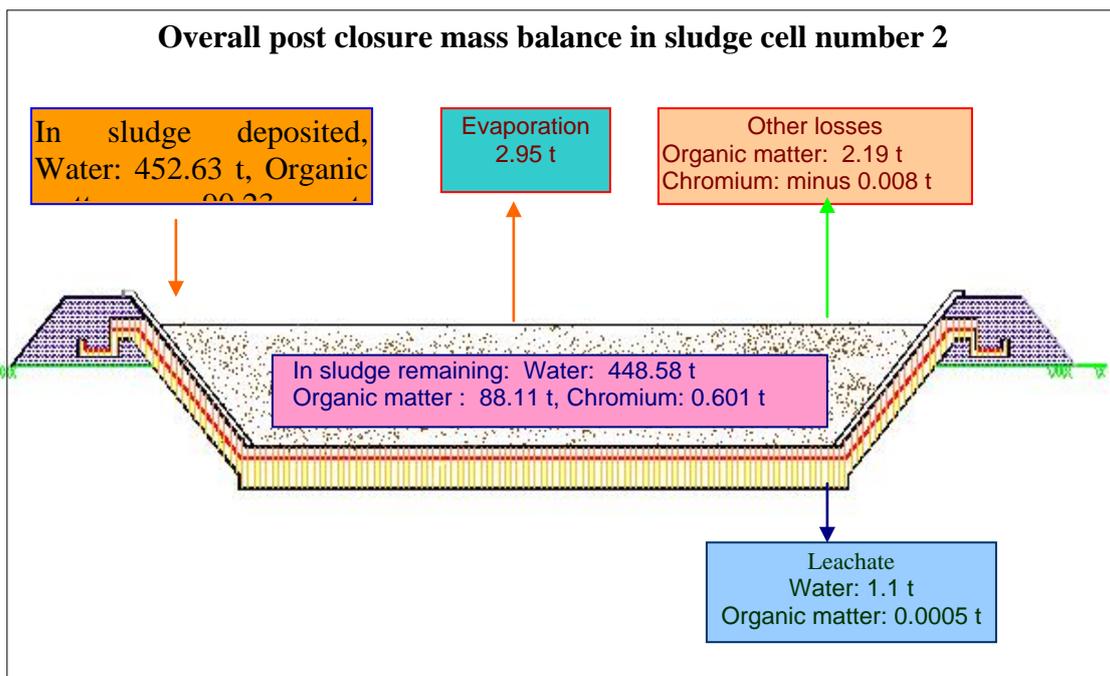
Overall Post closure mass balance of Cell-2 of sludge landfill at Ranitec (Part -3)

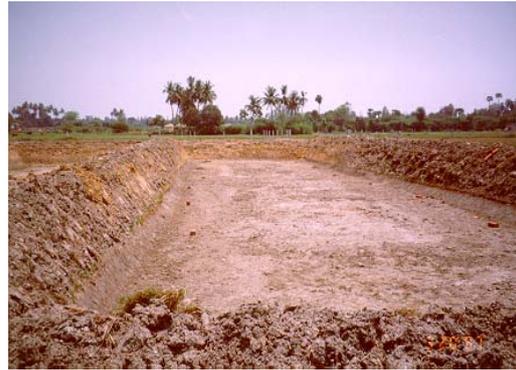
After excavation

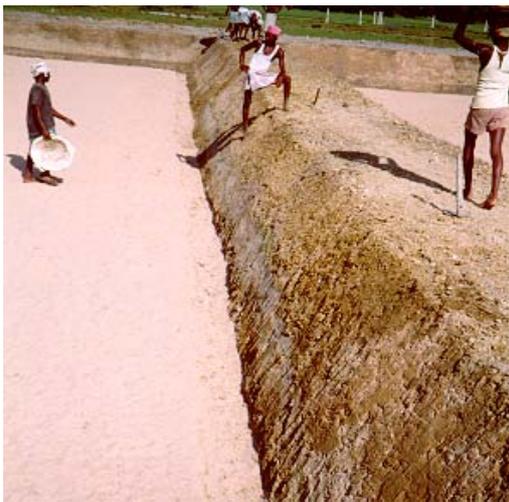
Filling first layer of sand

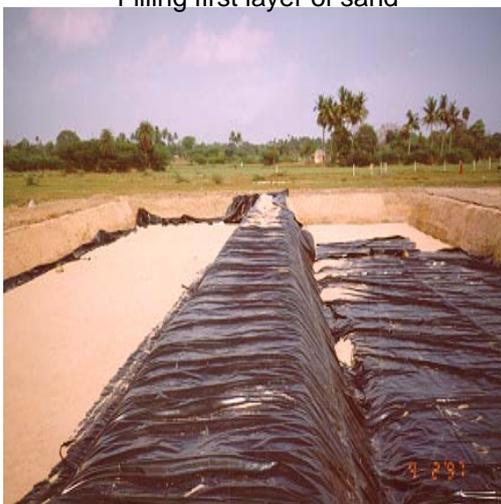
Laying LDPE sheet

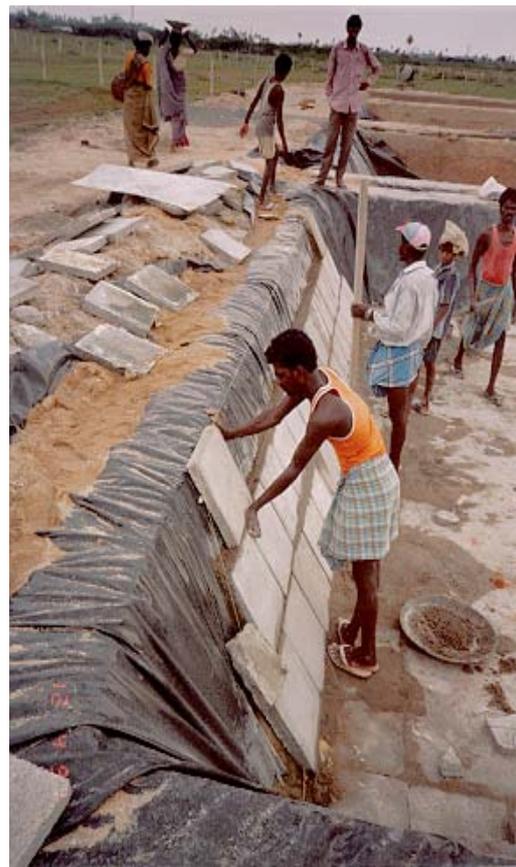
Fixing concrete slab on sides

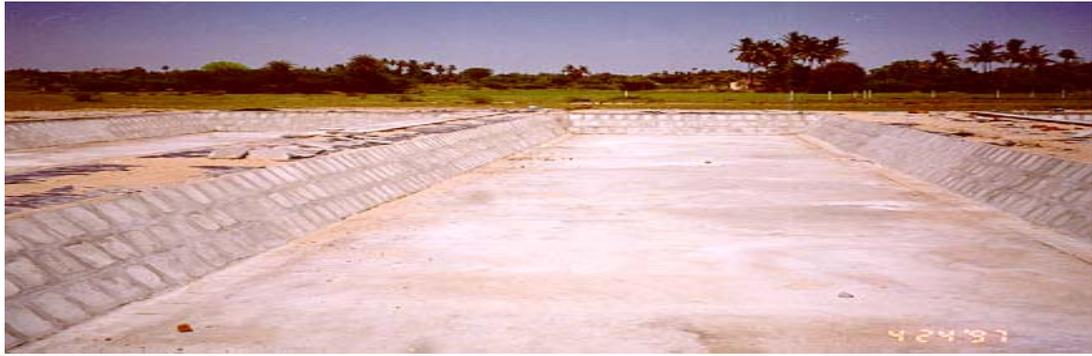
After concreting bottom & sides

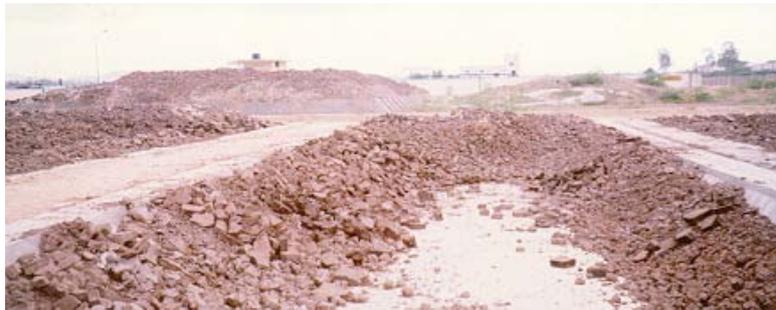
After first set of filling

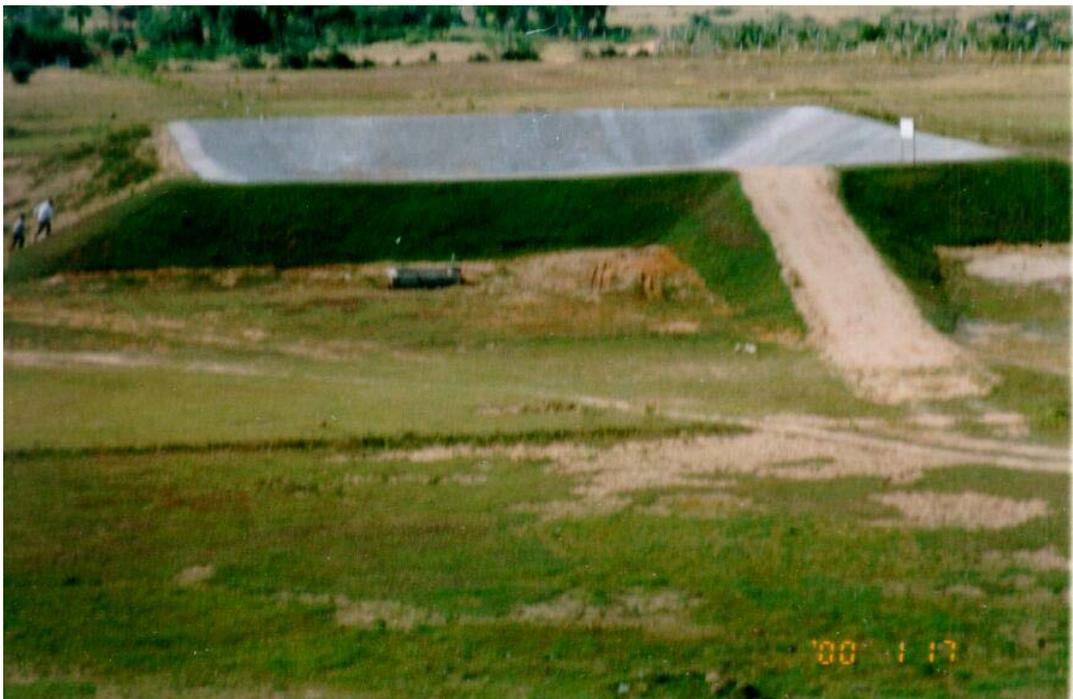
Overview of the landfill at CETP-Vishtec, Melvisharam

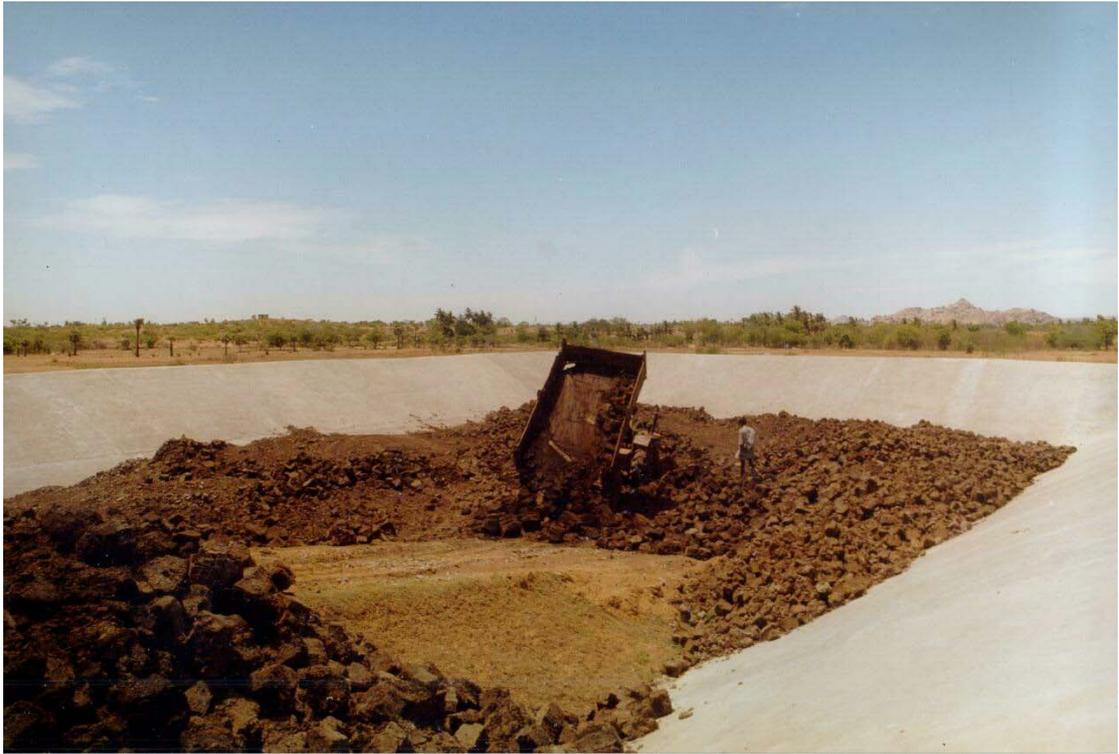
Sludge deposited in the landfill
